**ASBESTOS,
LEAD BASED PAINT
& MOLD INSPECTION
AT
CUMBERLAND CITY HALL BUILDING
402 WEST MAIN STREET,
CITY OF CUMBERLAND,
HARLAN COUNTY, KENTUCKY**

12 May 2014

Re: Asbestos, Lead Based Paint, and Mold Inspection Report
City Hall Building
1509 East Main Street
Cumberland, Harlan County, Kentucky
AMEC Project Number 779980001.0003.010

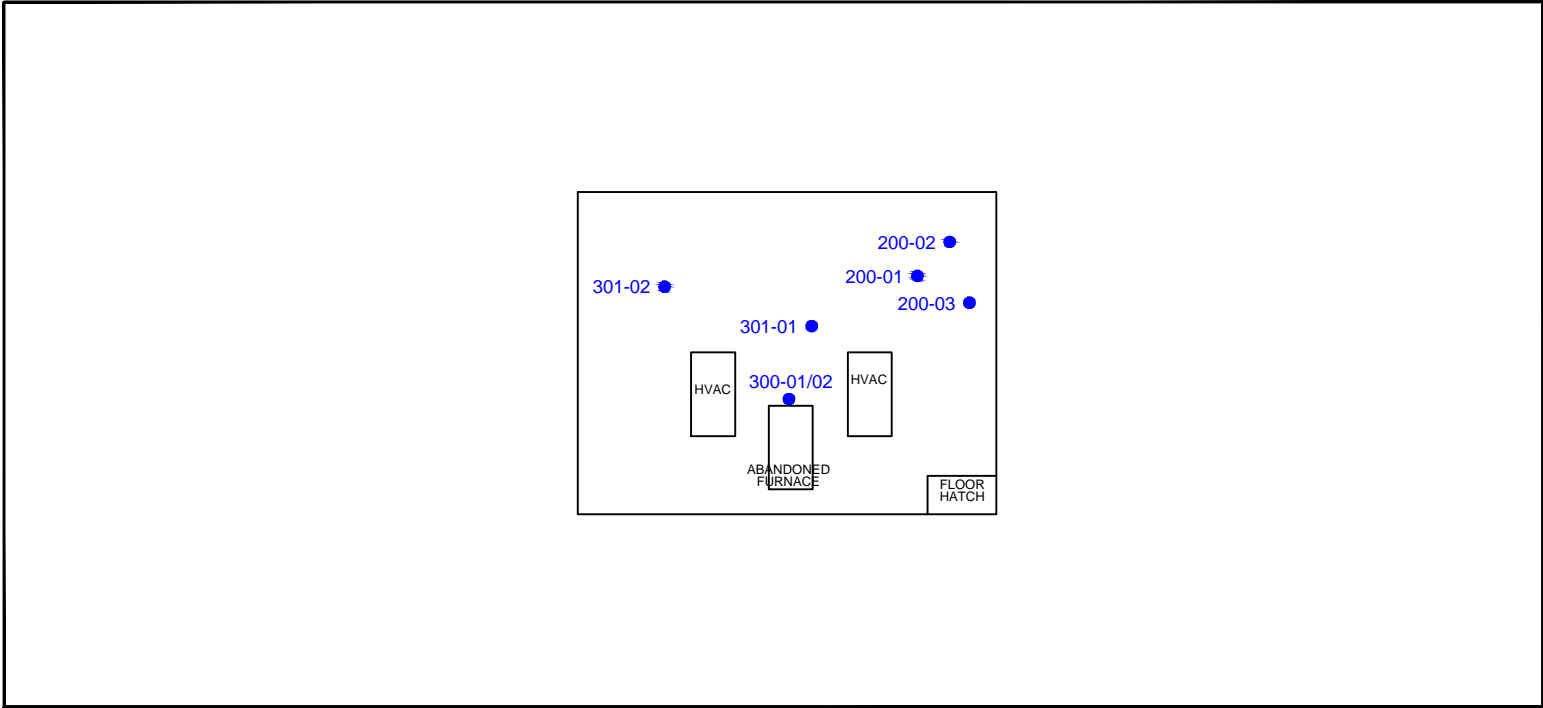
FIG.
3

BASEMENT ASBESTOS SAMPLE LOCATIONS

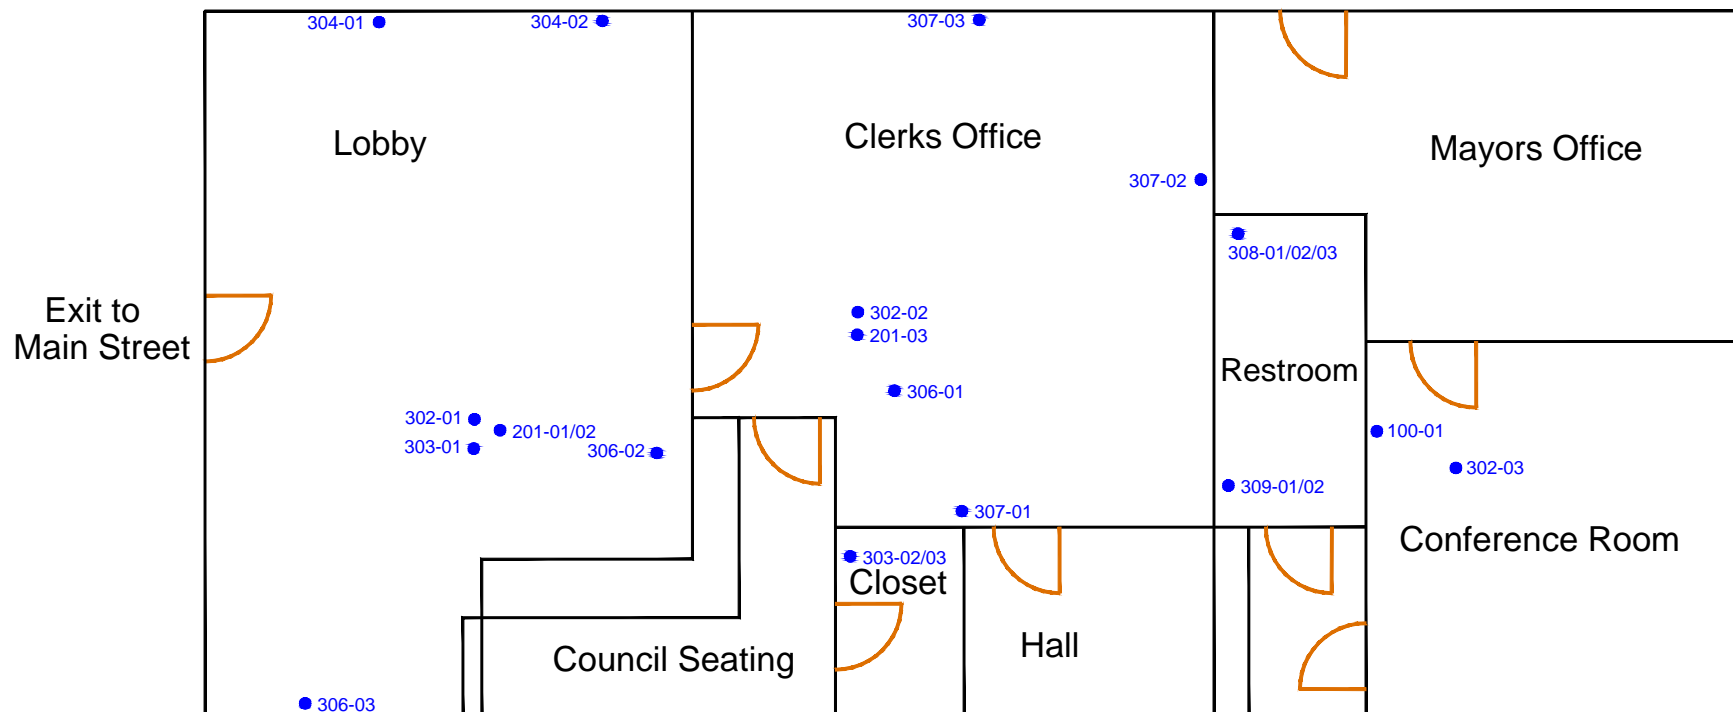
FIG.
4

1ST FLOOR ASBESTOS SAMPLE LOCATIONS

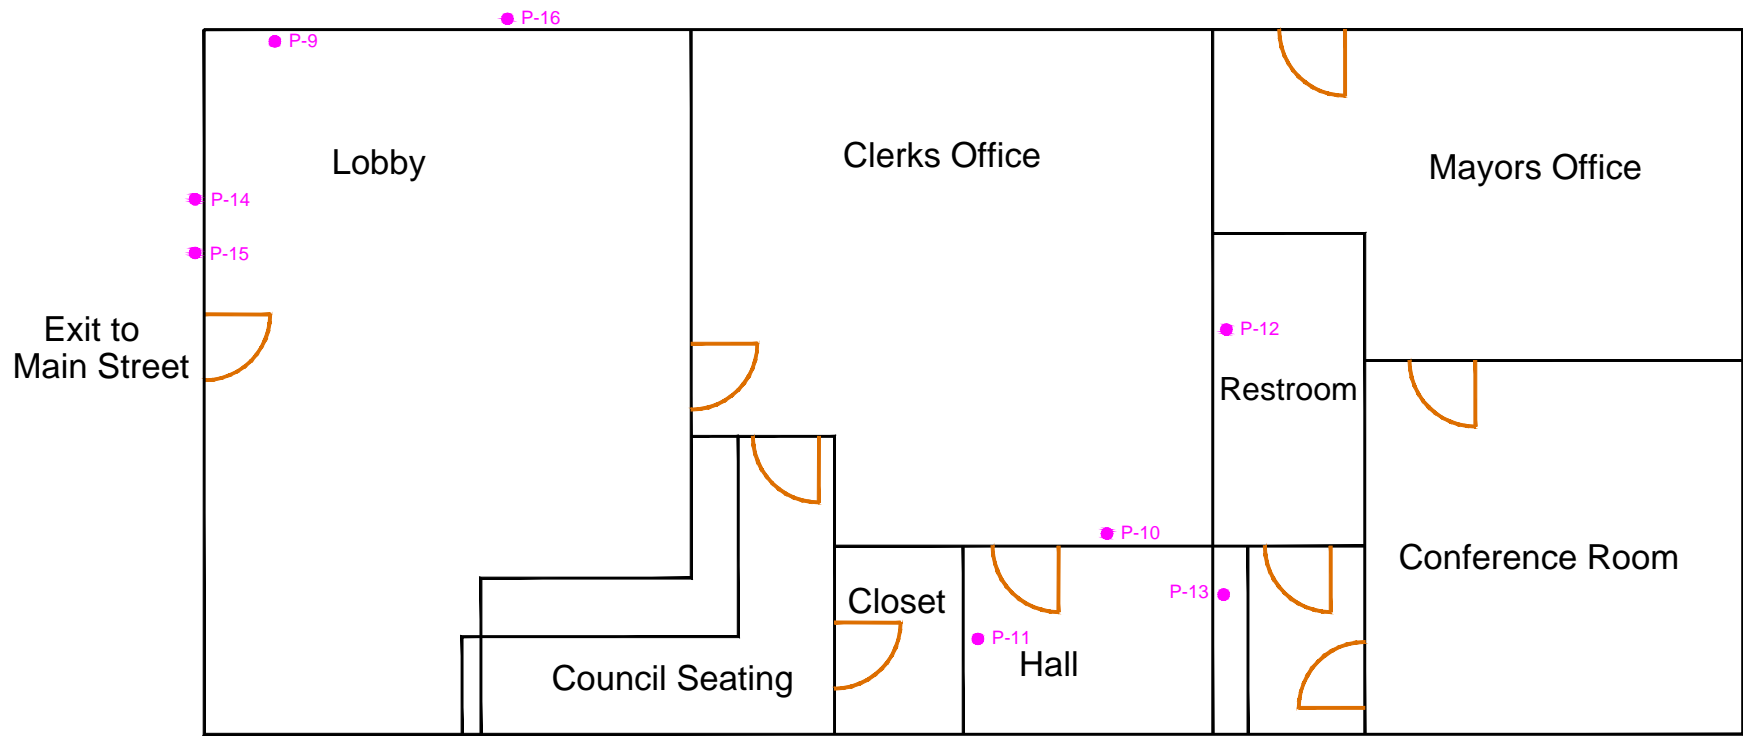
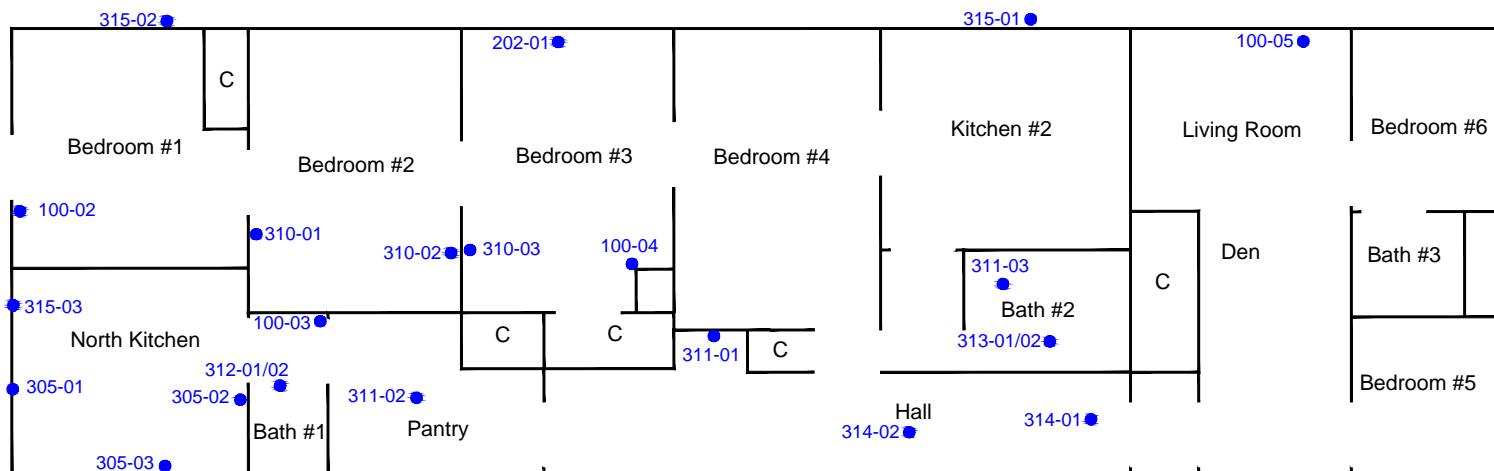
**FIG.
6**

Window glazing results were positive for the presence of asbestos on the second floor. The individual window frames throughout the second floor of the building showed a variety of repair methods including glass, wood, and empty panes. Therefore, due to this variation, it is recommended that all window glazing for the second floor windows should be treated as asbestos containing building material.

2ND FLOOR ASBESTOS SAMPLE LOCATIONS

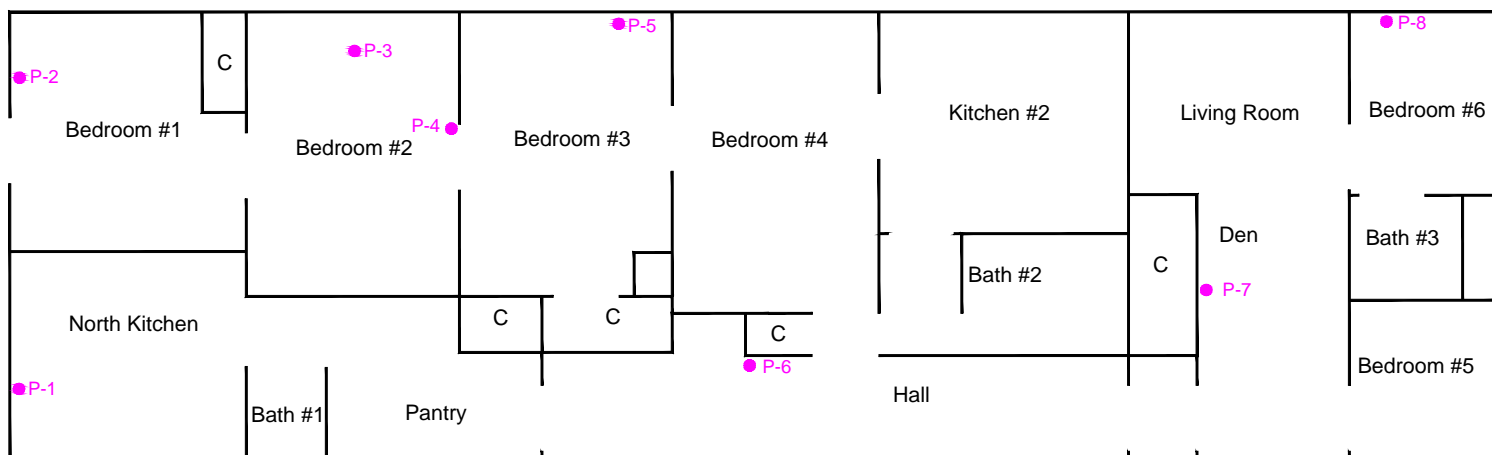
**FIG.
7**

Sample	Location	Component	Substrate	Condition	% wt.
P-1	2 nd Floor Kitchen	Green Paint on Window Sill	Wood	Poor	0.43
P-2	2 nd Floor Bedroom #4	Yellow Paint on Baseboard	Wood	Poor	0.19
P-3	2 nd Floor Bedroom #2	White Paint on Wood Shelf	Wood	Poor	0.016
P-4	2 nd Floor Bedroom #3	White Paint on Wood Door	Wood	Poor	0.12
P-5	2nd Floor Bedroom #3	White/Brown Paint on Wood Window Frame	Wood	Poor	1.2
P-6	2 nd Floor West Main Hall	Off White Paint on Wall	Plaster	Poor	0.12
P-7	2 nd Floor Den/Living Room	Green & White Paint on Wall	Plaster	Poor	0.45
P-8	2 nd Floor Bedroom #6	Brown & Red Paint on Wall	Plaster	Poor	0.095
P-9	1 st Floor Lobby	White/Green Paint on Wall	Plaster	Good	0.23
P-10	1 st Floor Clerk's Office	Brown Paint on Wall	Drywall	Good	<0.011
P-11	1 st Floor Hall	Beige Paint on Wood Trim	Wood	Good	<0.018
P-12	1 st Floor Bathroom	Yellow Paint on Wall	Plaster	Good	<0.041
P-13	1 st Floor Hall	Mauve Paint on Hall Door	Wood	Good	0.18

2ND FLOOR PAINT SAMPLE LOCATIONS

- All contractors and employees should be alerted to the presence and location of the identified and presumed LBP and hazards, in accordance with applicable OSHA regulations. It is recommended that a qualified LBP contractor perform all abatement.

- Work practices that disturb LBP shall comply with the OSHA Lead in Construction Regulations. LBP shall be removed if activities will create airborne lead levels that exceed the OSHA action limit of 30 micrograms per cubic meter (e.g. negative exposure assessment). Workers shall wear personal protective equipment (e.g. respirators, suits) until the negative exposure assessment is completed.
